LANDSLIDES AND DEBRIS FLOWS IN THE TASMAN DISTRICT CAUSED BY THE DECEMBER 2011 AND JUNE 2013 RAIN STORMS

CHALLENGES WITH SEDIMENT DYNAMICS IN MARLBOROUGH'S LOWER WAIRAU RIVER

HORIZONS REGIONAL COUNCIL'S FLOOD FORECASTING SYSTEM

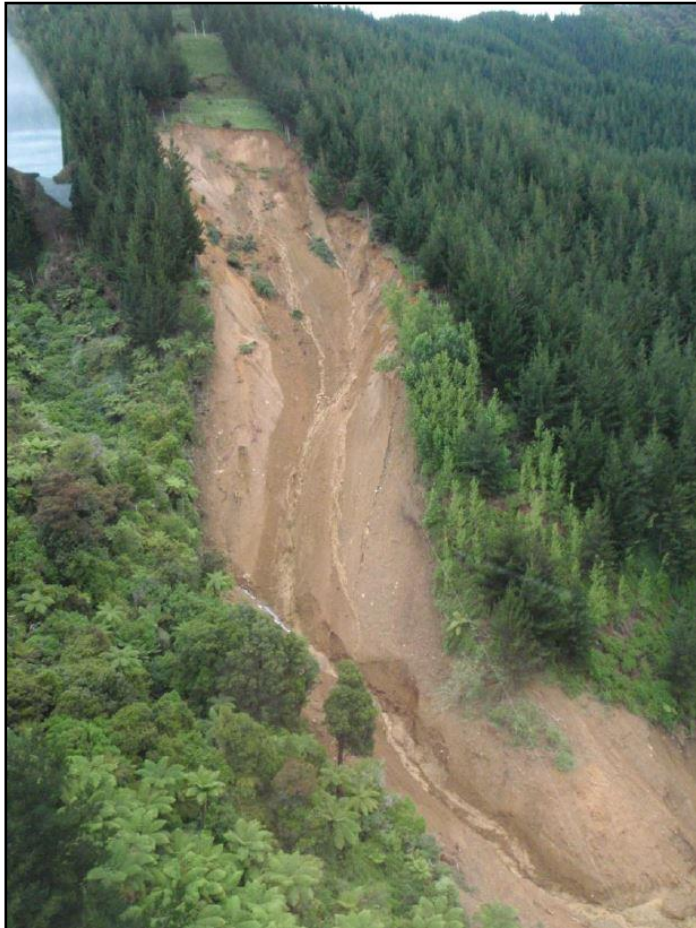
Large Slip in Ellis Creek Catchment (2011 - Courtesy of Paul Woperies)

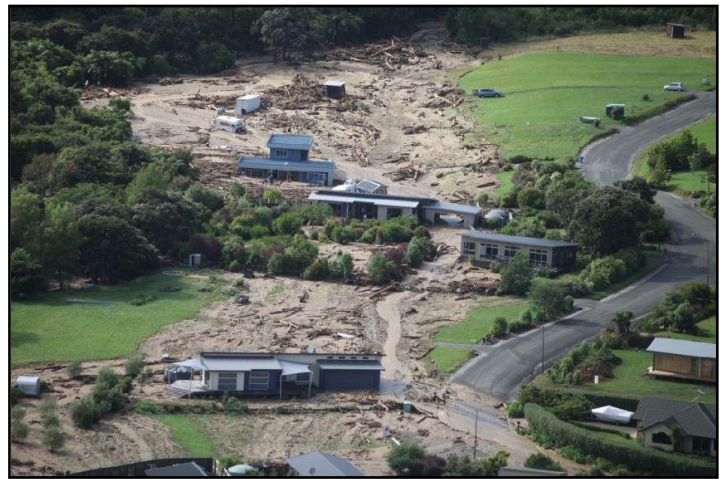
A debris flow is a very rapid to extremely rapid flow of water-saturated sediment and debris that travels down a steep channel. Material is contributed from landslides on the surrounding hillslopes and from sediment and vegetation scoured from the channel as the debris flow travels downstream. It is capable of carrying large boulders and logs and can be destructive when it reaches a fan or other depositional surface. A debris flood is a very rapid surging flow of water, heavily charged with debris, in a steep channel. A debris flood almost always occurs as a continuation downstream of a debris flow, but can occur in the absence of a debris flow. Debris flows were responsible for the worst damage to houses and other infrastructure in Nyhane Drive and Pohara Valley. This mainly occurred where the stream flowed onto the upper parts of the fans. Further down the fans, as the larger debris was deposited and velocities reduced, debris floods continued often to the coast and many houses and properties were affected by the deposition of finer sediment.

Debris Flow on upper part of Nyhane Drive Fan (2011 - Courtesy of Tim Cuff)

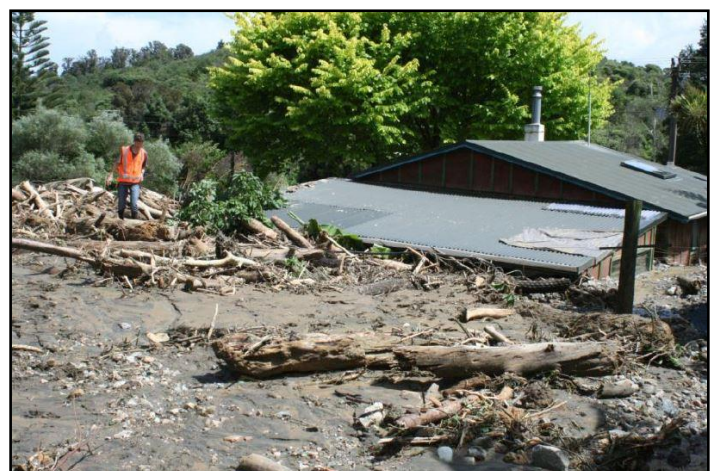
Debris Flow Deposit surrounding property at 64 Pohara Valley Road (2011 – TDC photo)

For the Nyhane Drive and Pohara Valley communities, mitigation options largely involve engineering works, land use and land management. At Nhyane Drive there are still areas of the fan that are not built on, and which could be modified to contain debris flow and debris flood sediment. The existing channel which delivers sediment to the fan could also be enlarged and possibly lined, and moved slightly eastward away from existing houses to flow onto areas of the adjacent fan which is confined between rows of hills, severely limiting mitigation options on the fan. The stream channels could be enlarged and lined, and culverts significantly enlarged. Consideration could be given to building debris-retention structures in the upper reaches of the two largest catchments that drain onto the fan.

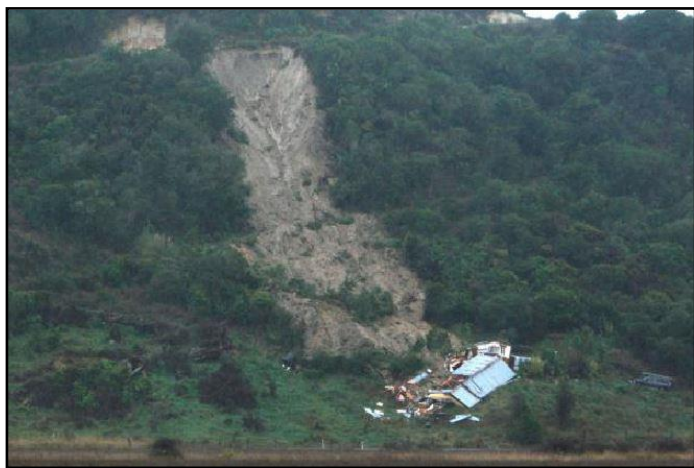
Fatal Landslide at 597 Kaiteriteri-Sandy Bay Road (2013 – Nelson Mail photo)

A site inspection was made of the fatal landslide site at Otuwhero Inlet. The landslide occurred at ~1 pm on Sunday 16 June after ~180 mm of rain fell in the preceding 24 hours and ~80 mm fell in the preceding 4 hours. The house was pushed several meters off its piles and collapsed, and the woman's body was subsequently recovered from the landslide debris outside the house. The landslide occurred in an area of convergent drainage on the slope directly above the house. The head scarp of the landslide is level with an access track that cuts across the slope. The house had been built on material deposited by an earlier (paleo-) landslide.

Factors contributing to the landslide were: the high intensity rainfall, the deeply-weathered Separation Point Granite lithology, steep convergent slopes, and probably the side castings deposited along the outer edge of the track during construction and maintenance. The death of the occupant was the result of the house being located at the base of slopes susceptible to landsliding, and the light-weight materials with which the house was constructed.

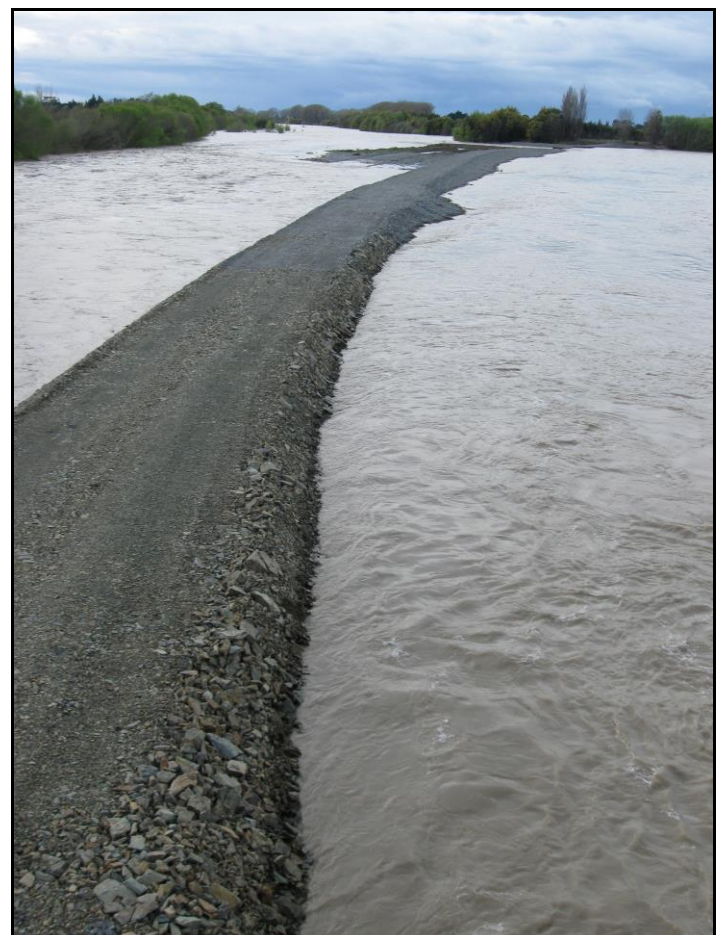
The Wairau Diversion's Erodible Bank looking downstream to the head of the Wairau Diversion

K. Christensen's predictive sediment transport analysis led to the decision and resource consent to construct an Erodible Bank at the head of the Wairau Diversion to divert more frequent scouring-flows ($+400 m^3/sec$) down the Lower Wairau River. The initial construction of the bank followed in late 2009 with the combination of a non-erodible rock groyne extending approximately $\sim 35 m$ downstream of a rail bridge pier followed by a $\sim 450 m$ long and $\sim 15 m$ wide erodible bank, which divides the upper end of the Lower Wairau and Wairau Diversion. The bank's level at a fuse location is set to overtop and begin washing out at a combined Wairau flow of $1,400 m^3/sec$.

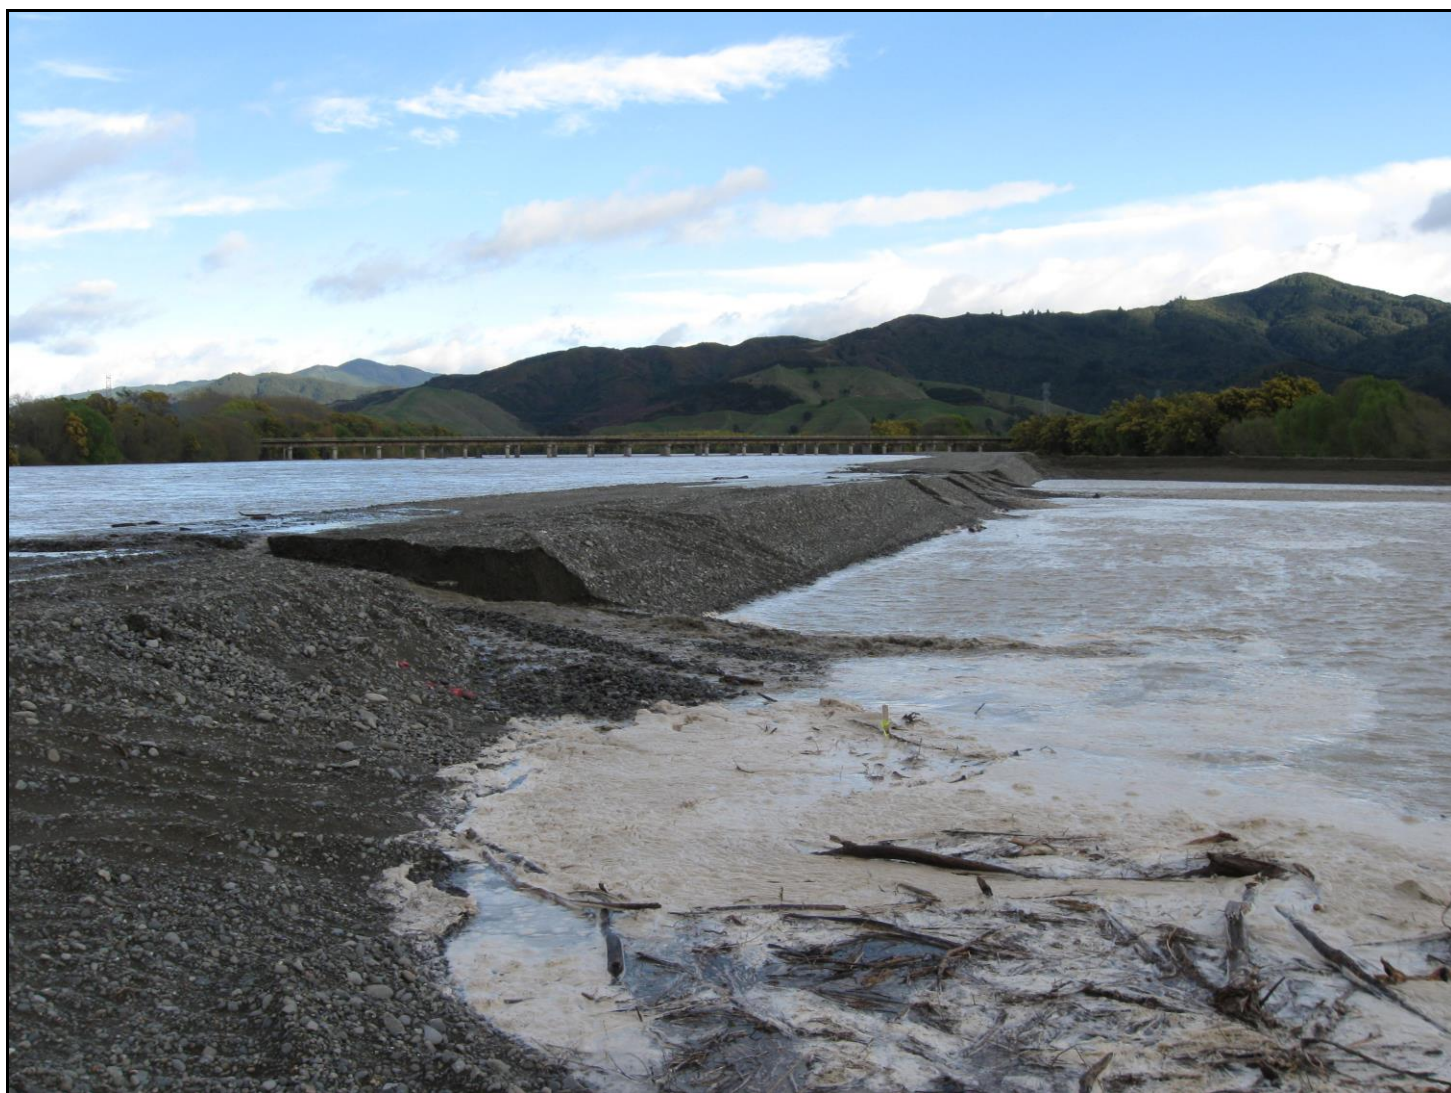
Looking upstream at the Erodible Bank just as flood waters are beginning to breach the Fuse Location

These freshes and floods resulted in washout and rebuild of the Erodible Bank 8 times with a combined rebuild expenditure of ~\$80K. The cost to reinstate the bank varied for each washout between ~\$8K and +\$20K depending on the degree of washout and amount of rebuild material required.

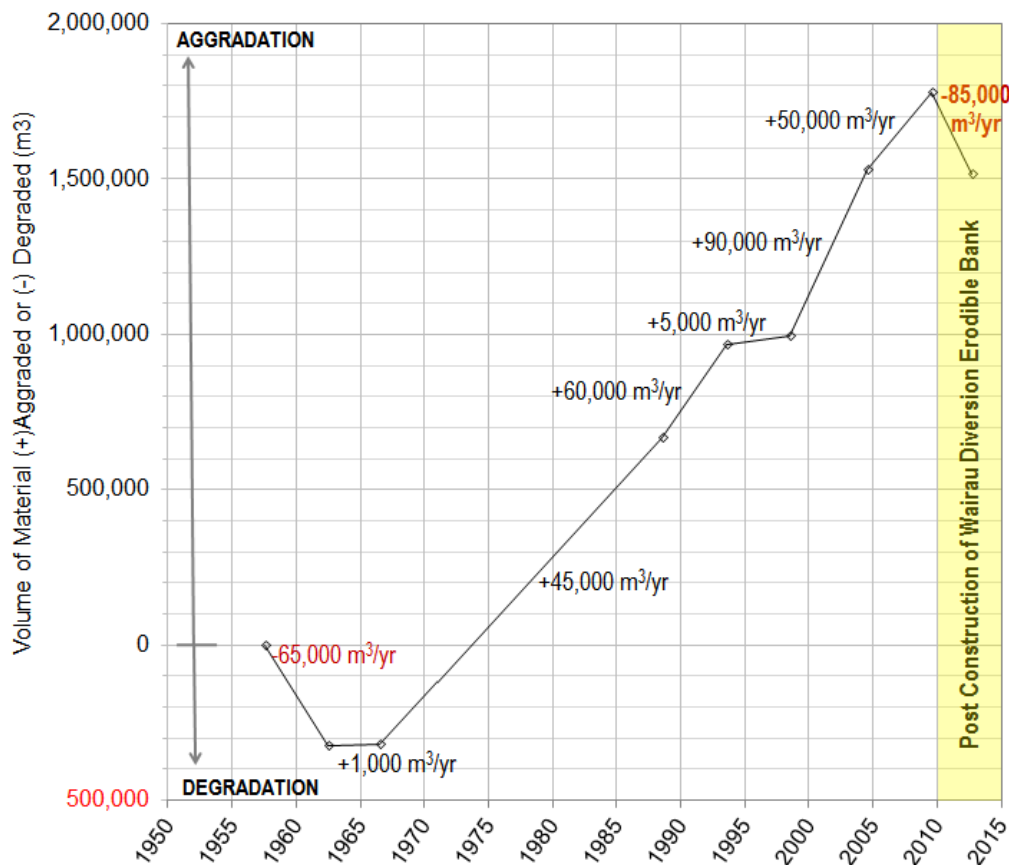
Estimated Sediment Volumetrics in the Lower Wairau River post-excavation of the Wairau Diversion and post-construction of the Erodible Bank

The results from this latest survey show for the first time since excavating the Wairau Diversion the bed of the Lower Wairau River as a whole is losing material; thus the anticipated scour from the Erodible Bank's influence is occurring. It is estimated that the entire bed of the Lower Wairau has gone down by an overall average of ~60 mm since the introduction of the Erodible Bank. It is also estimated that the river has lost ~260,000 m³ of sediment since the Erodible Bank was first constructed. At a cost of \$0.30/m³ this represents excellent value compared to mechanical dredging which would likely be in excess of \$10/m³.

approximately $\sim 2,000,000 m^3$ of sediment was deposited along the bed of the Lower Wairau River in the time between the Diversion's introduction and 2010; raising the Lower Wairau's bed upwards of $\sim 1.5 m$ in some locations.
